NATIONAL TRANSPORTATION SAFETY BOARD

Field Notes

WPR19LA189

Aircraft: Experimental, RV-14, Registration Number: N365EM

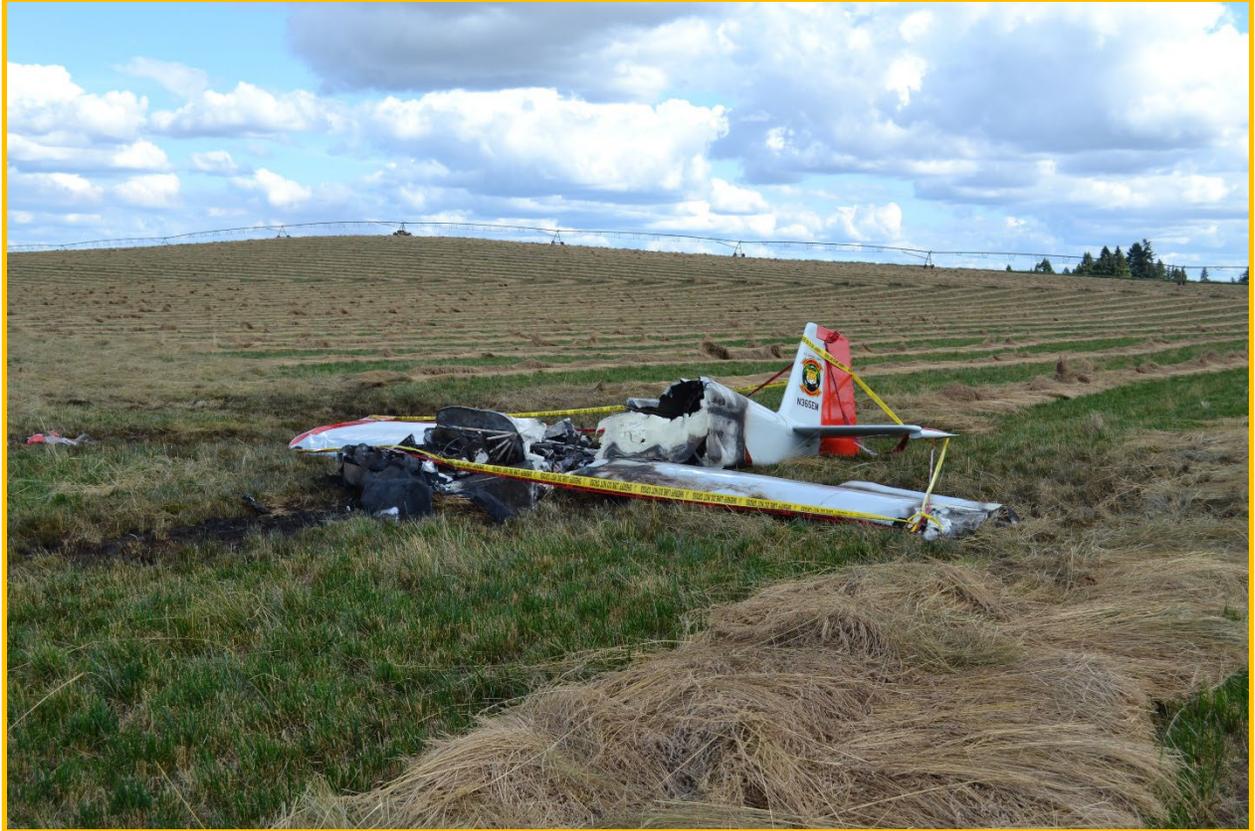
Figure 2: View from front of wreckage.

The main wreckage consisted of all major structural surfaces. Flight control continuity was established.

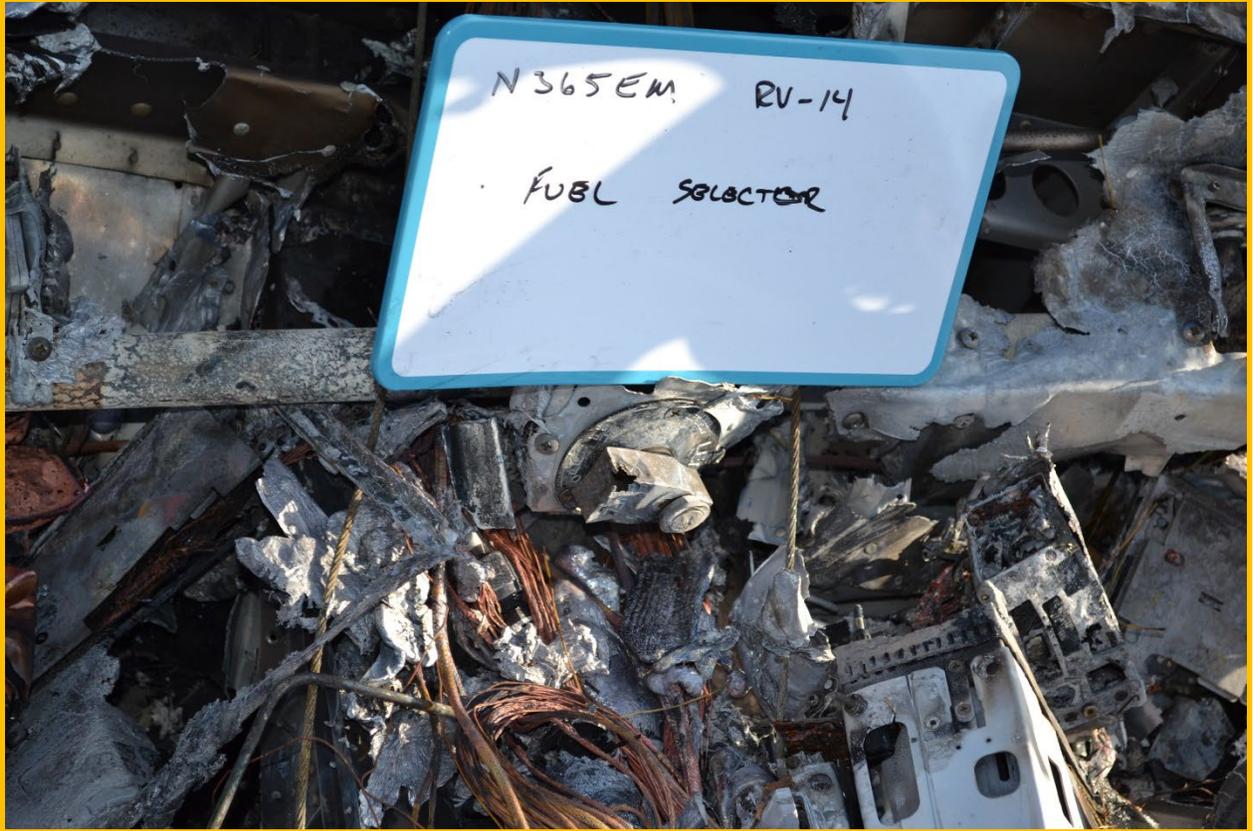
The main fuselage wreckage sustained thermal damage; the cockpit area was thermally destroyed. The fuel selector lever was set to the left fuel tank. The throttle, propeller, and mixture levers were found in unknown position.

Figure 3: View of fuel selector lever position.

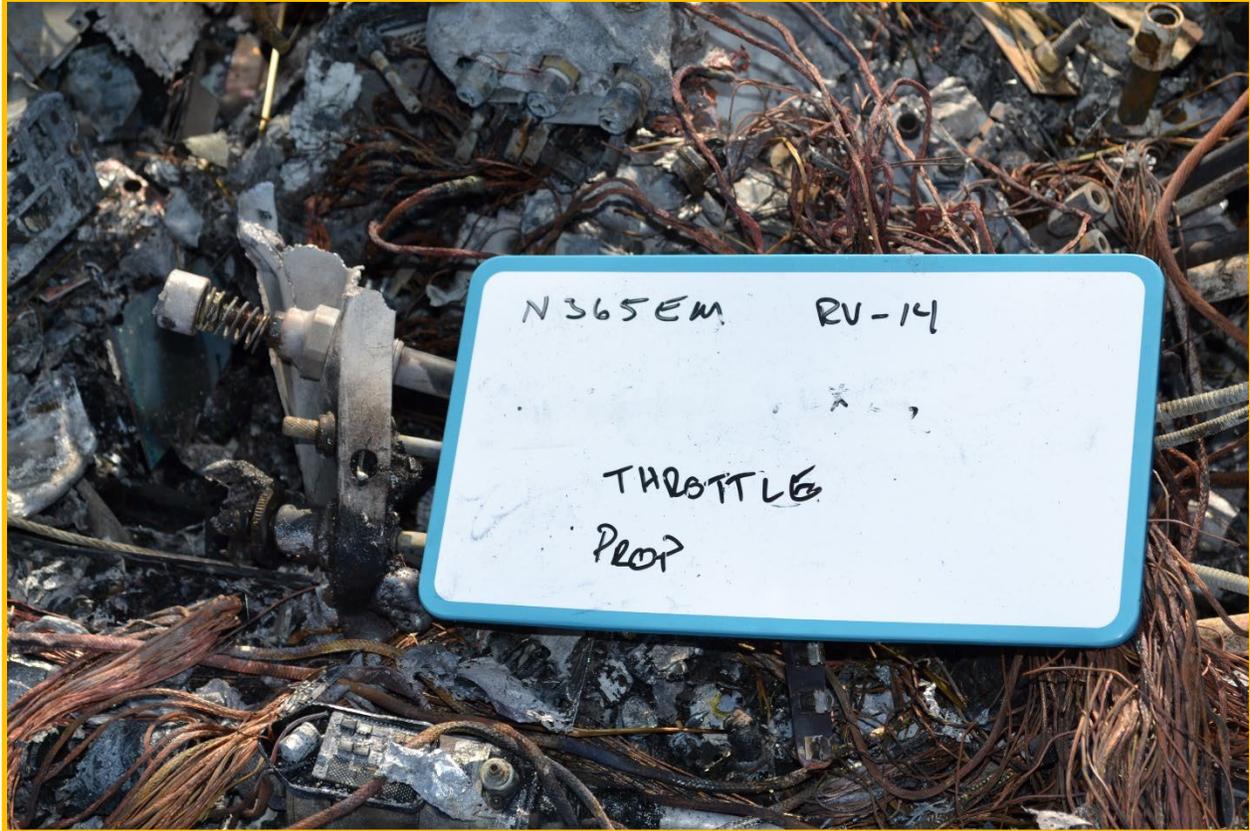
Figure 4: View of throttle and propeller lever position.

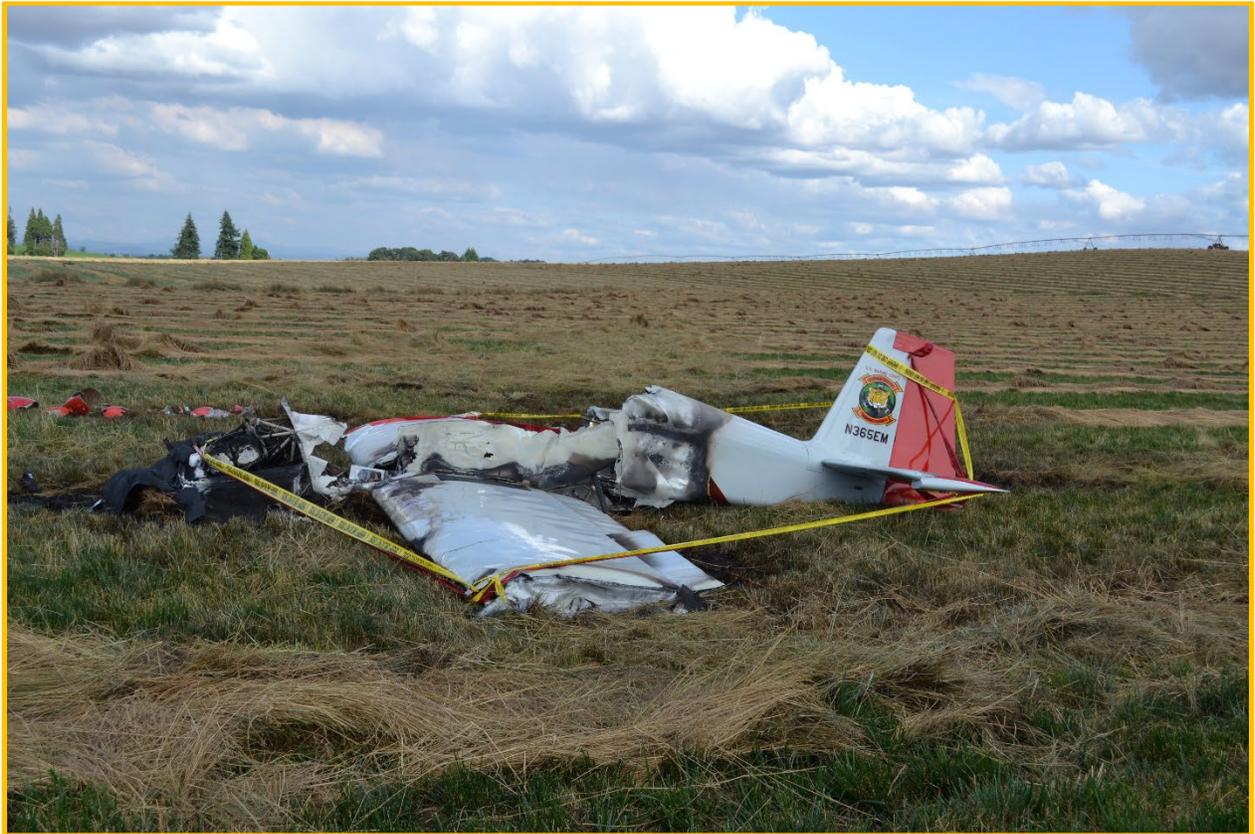
The left wing remained attached to the fuselage. Thermal damage was noted along the wing root. The leading edge displayed deformation and thermal damage. The top of the wing displayed some thermal damage. The fuel cap remained secured in its respective housing. About 13 gallons of fuel was noted. The fuel was tested for moisture using SARGEL, no moisture was detected. The wing tip displayed some impact damage. The aileron remained attached to the wing and

thermal damage was noted along the wing attachment points. The flap remained attached to the wing and displayed thermal damage along the wing root.

Figure 5: View of left side airplane wreckage.

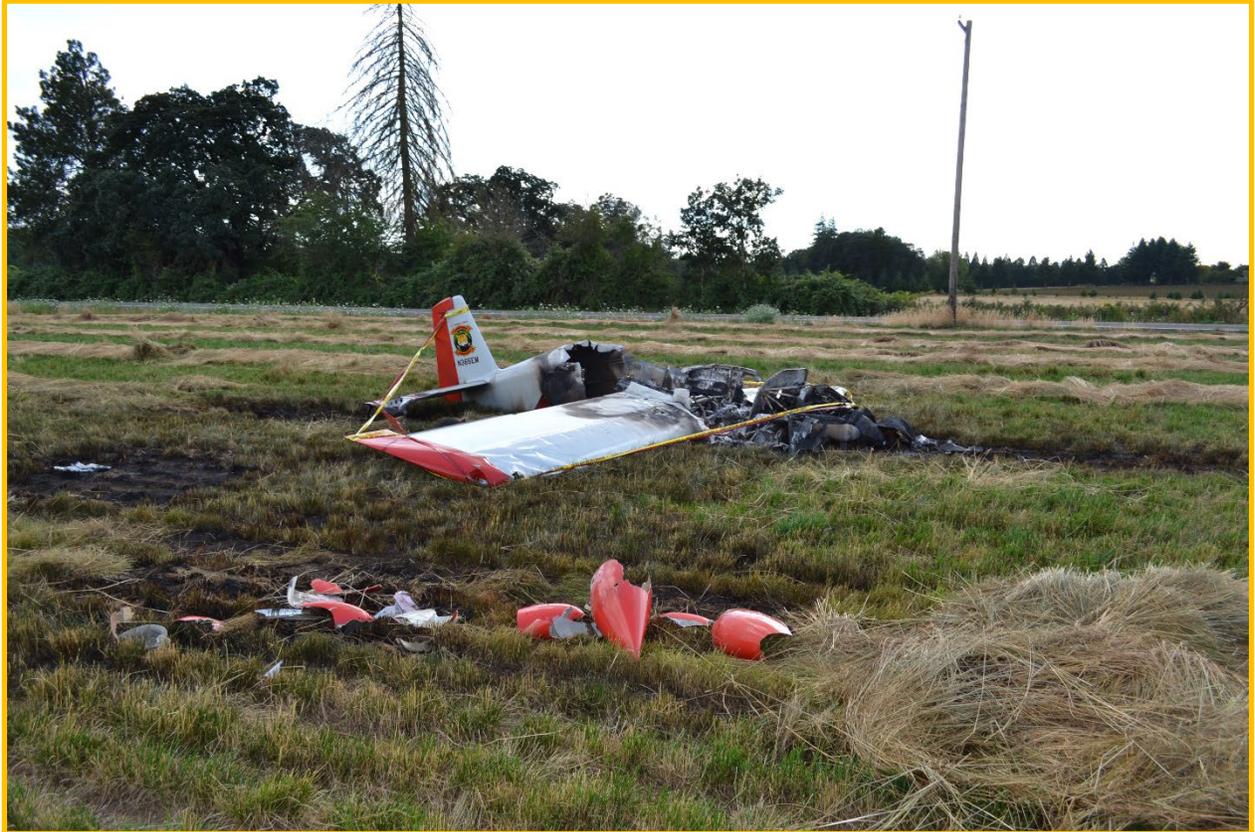
The right wing remained attached to the fuselage. Thermal damage was noted along the wing root. The leading edge displayed deformation and thermal damage. The top of the wing displayed some thermal damage. The fuel cap remained secured in its respective housing. About 6 gallons of fuel was noted. The fuel was tested for moisture using SARGEL, no moisture was detected. The wing tip displayed some impact damage. The aileron remained attached to the

wing and thermal damage was noted along the wing attachment points. The flap remained attached to the wing and displayed thermal damage along the wing root.

Figure 6: View of wreckage from the right side.

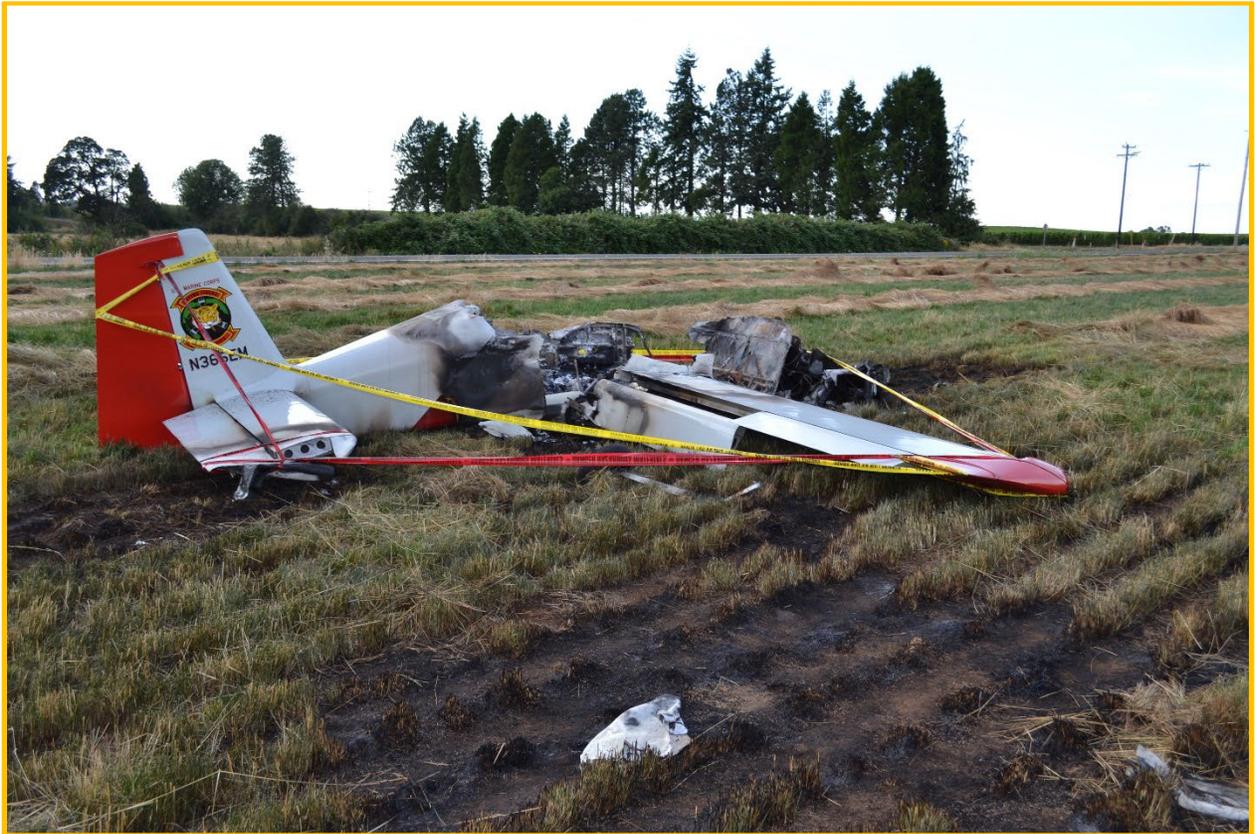
No impact damage was noted to the empennage, minor thermal damage was identified to the right horizontal stabilizer.

Figure 7: View of the right side of the empennage.

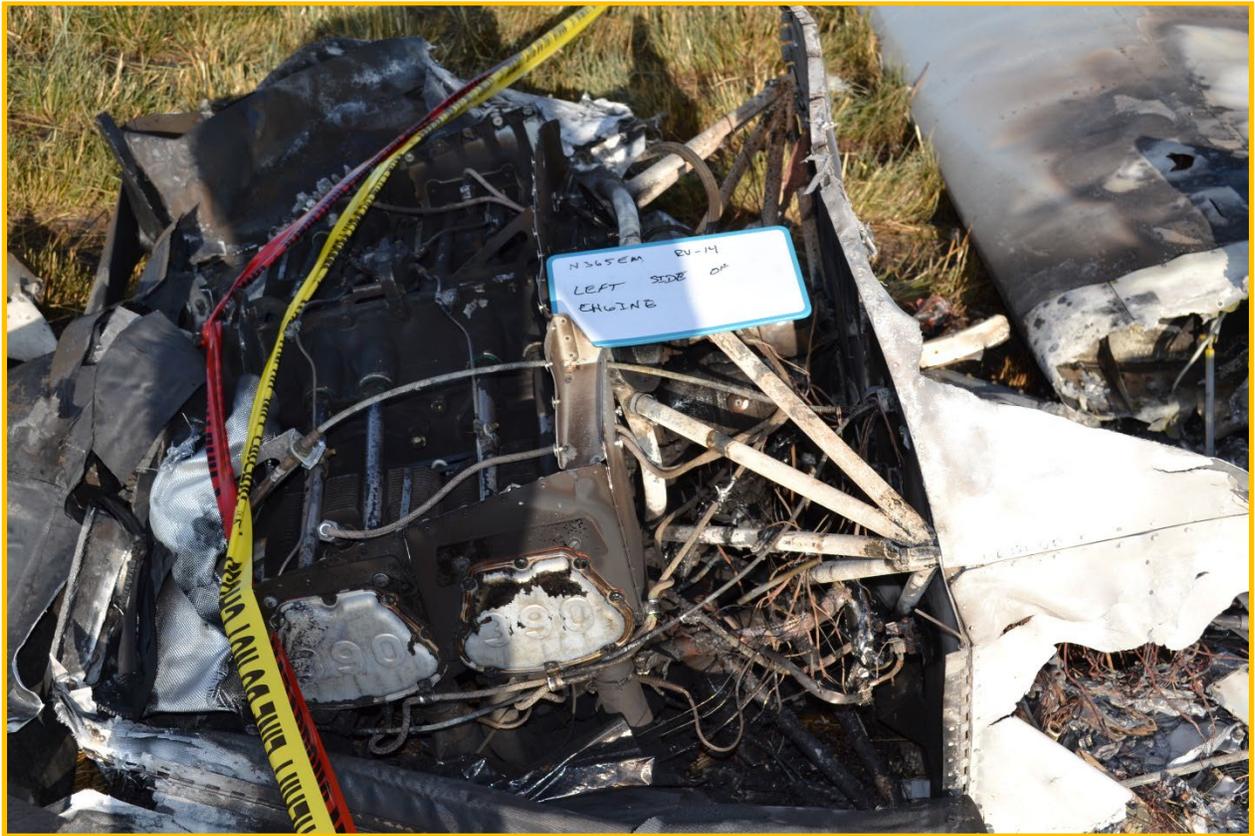
The propeller remained attached to the engine and displayed thermal damage. The engine sustained external heat distress and exhibited impact markings. The engine remained attached to the engine mount and firewall. The engine and accessory components were found intact in their normal positions within the engine compartment area. The engine sustained extensive thermal damage. The top part of the engine did have some indications of thermal damage, all of the spark plugs were noted to have sustained external heat distress. The left side of the engine did have

Figure 8: View of the left side of the engine.

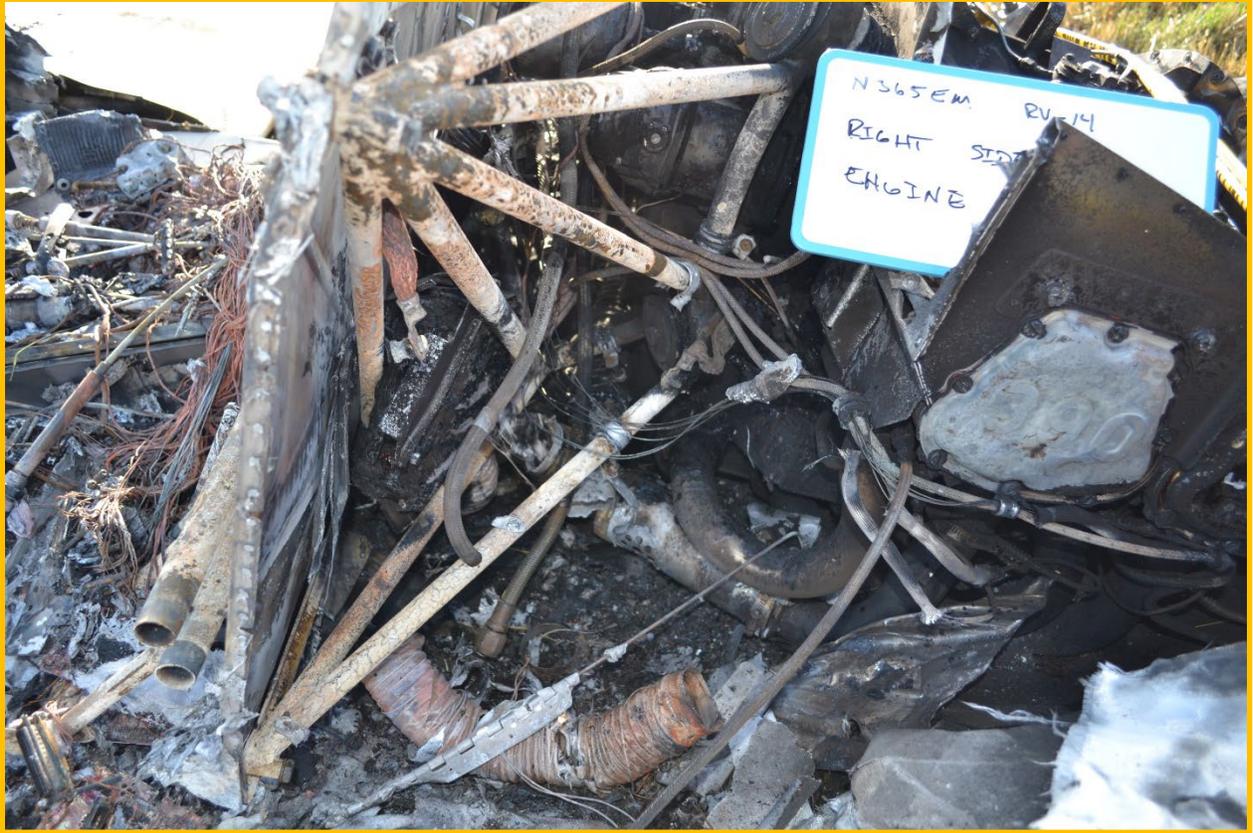
indications of thermal damage. The right side the of the engine displayed extensive thermal damage, with about 24 ounces of pooled melted metal near the firewall.

Figure 9: View of the right side of the engine.

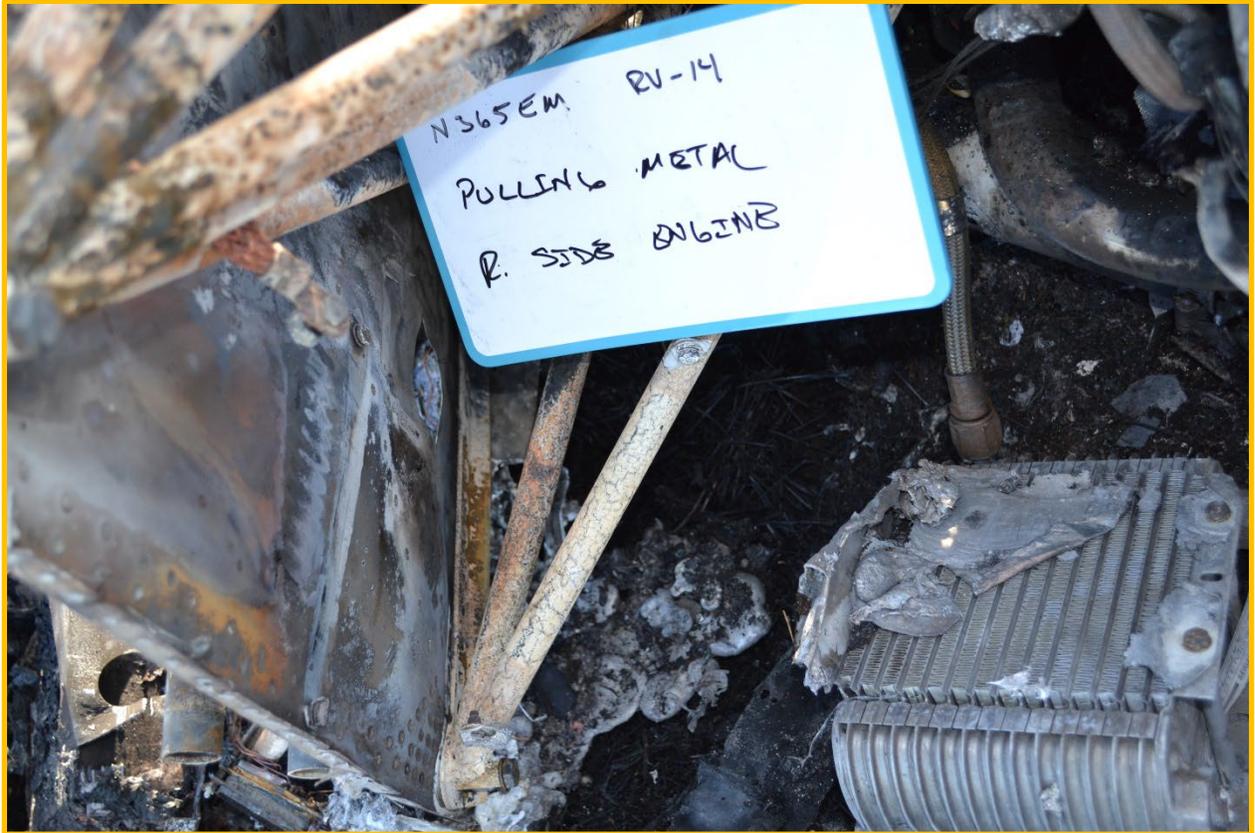
Figure 10: View of pooling metal on the right side of the engine.

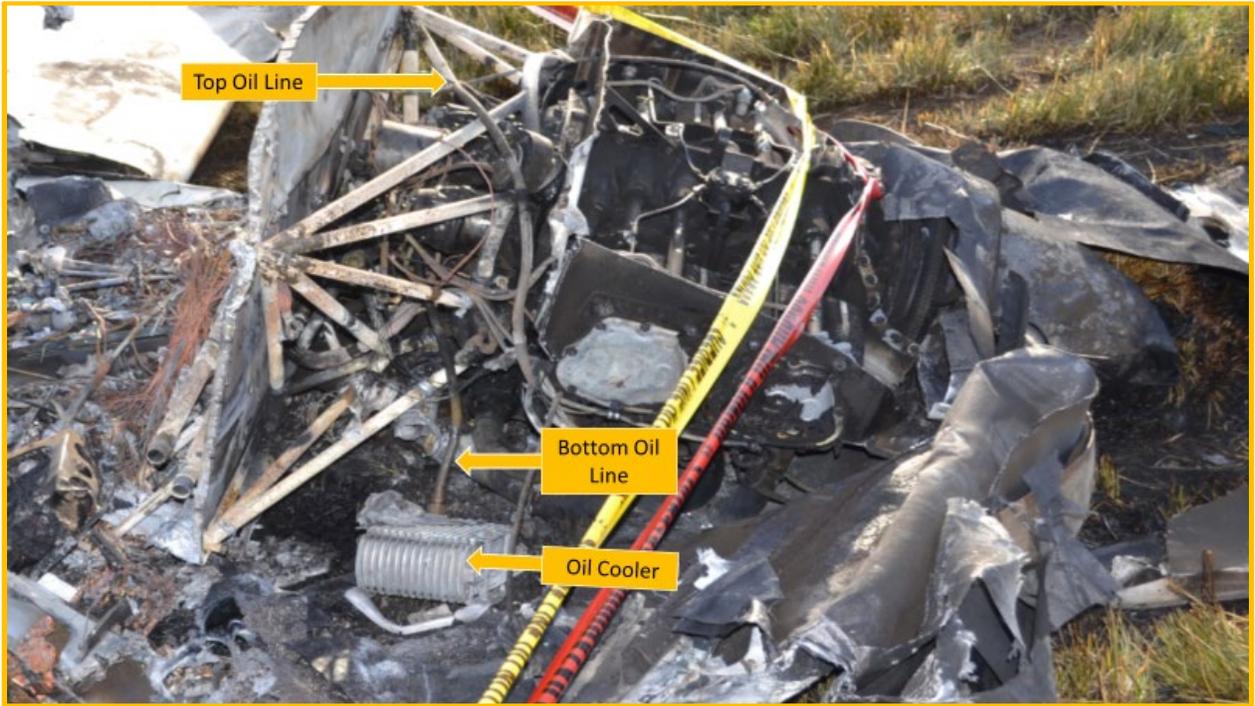
Further examination of the engine compartment revealed extensive thermal damage on the right side. Extensive thermal damage was noted in the area around the oil cooler. Further examination of the top oil line coming from the engine to the oil cooler indicated thermal damage and soot on the engine attachment point. On the oil cooler attachment point, the 90° elbow appeared to be deformed. The elbow connection to the oil cooler was fractured separated. Further examination of the AN-818 tee revealed that, when the fitting was turned about 720°, residual oil was noted

Figure 11: View of the engine oil cooler and lines.

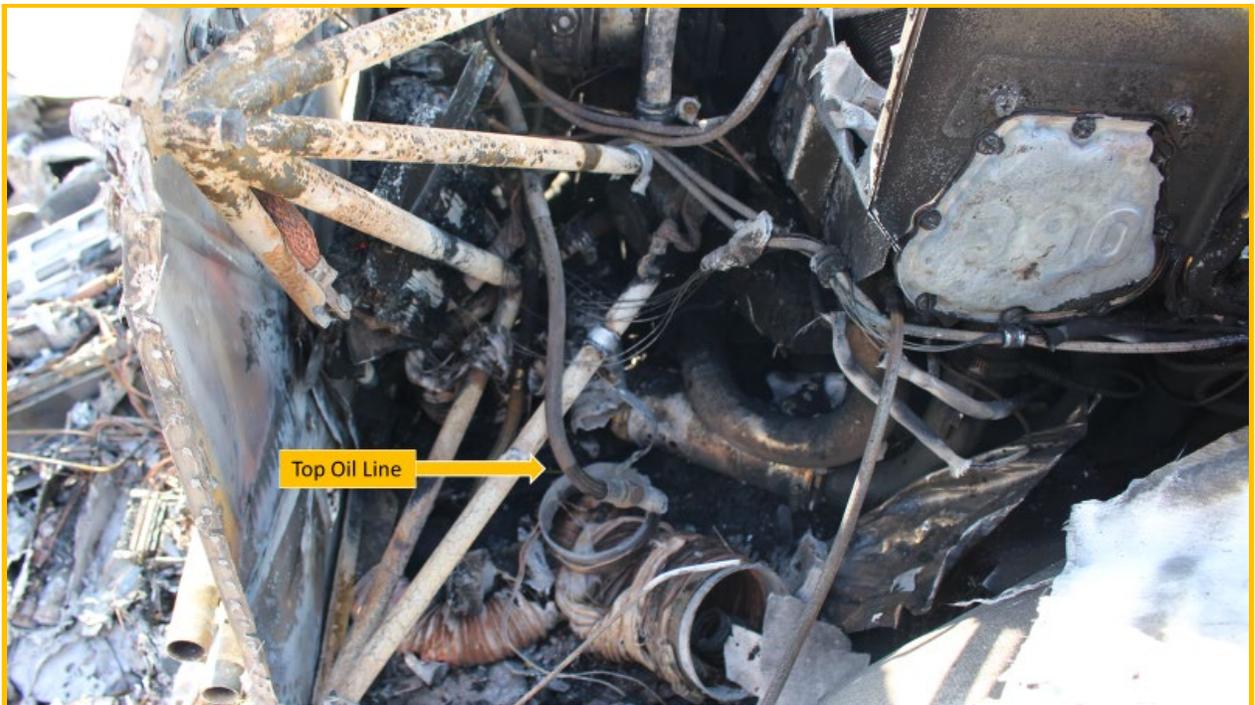
Figure 12: View of top oil cooling line.

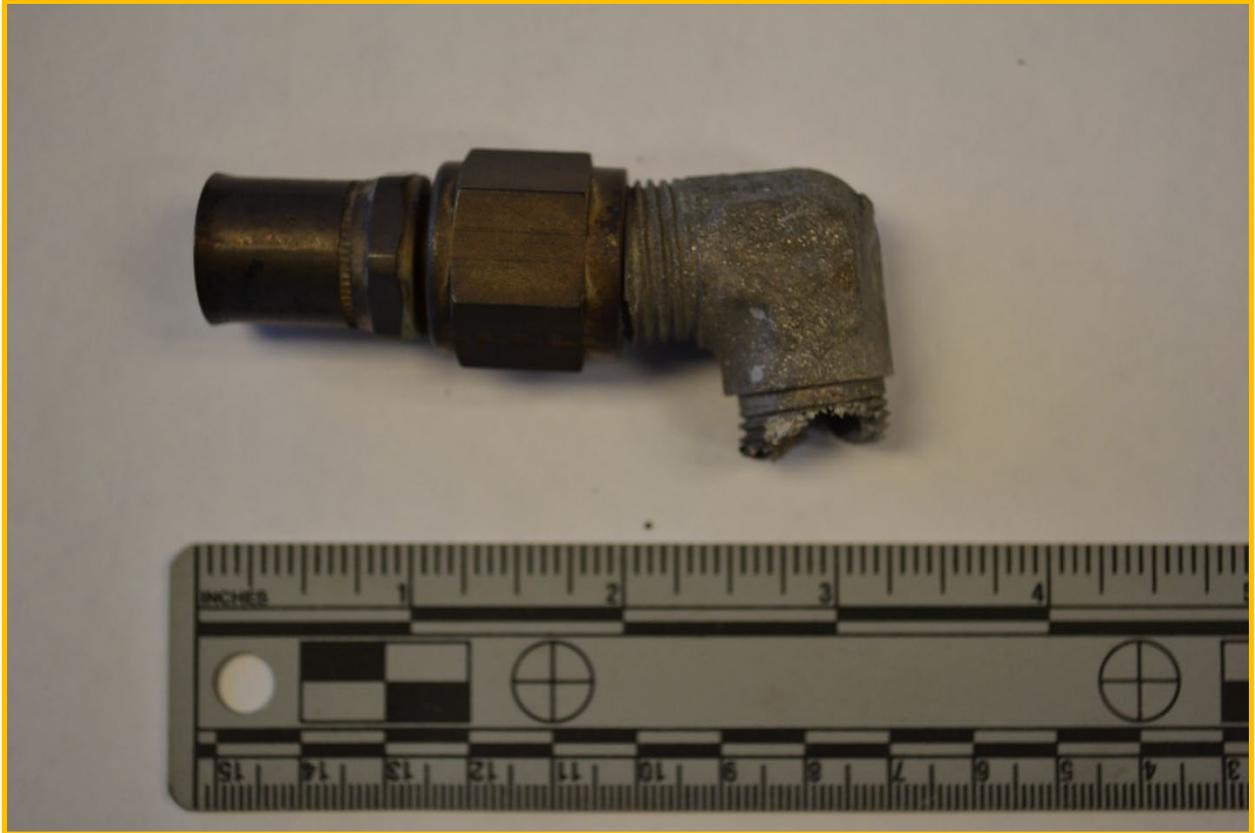
Figure 13: View of AN-818 tee and 90° elbow.

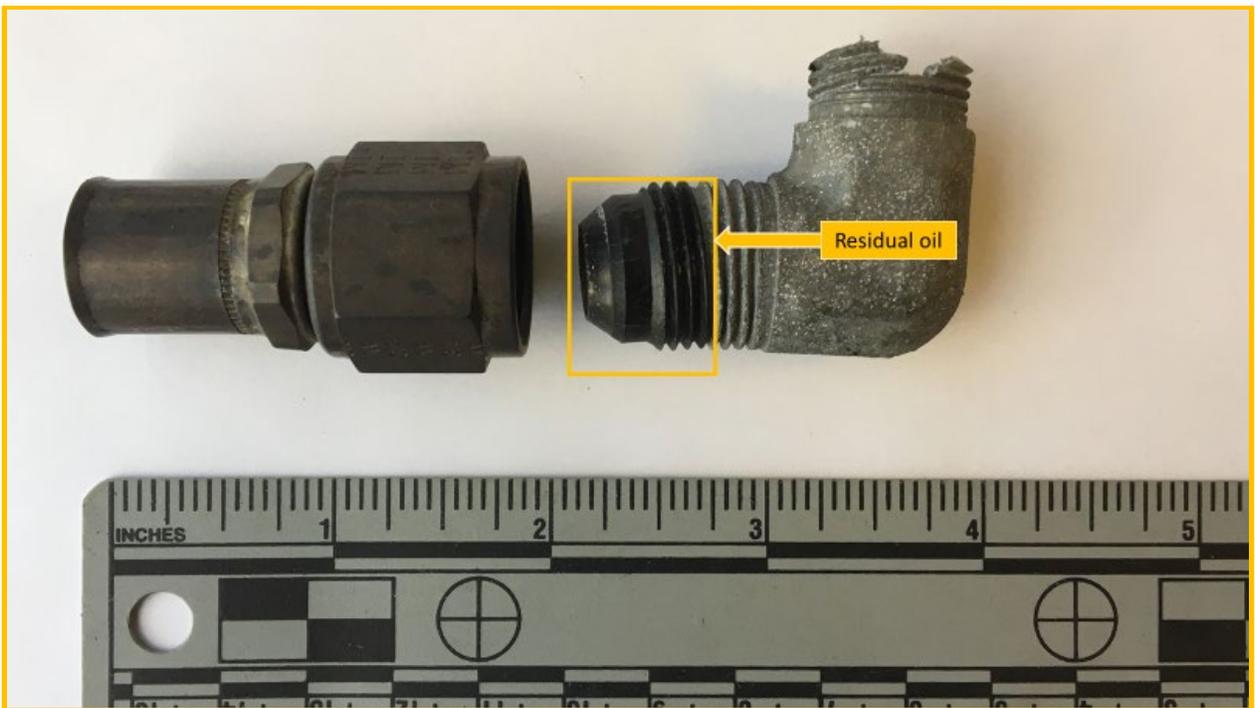
running across the thread line of two threads. Removal of the AN-818 tee revealed about three threads on the 90° elbow displayed residual oil, see figure 14.

Figure 14: View of residual oil on 90° elbow.
