NATIONAL TRANSPORTATION SAFETY BOARD

Field Notes

WPR19LA189

Aircraft: Experimental, RV-14, Registration Number: N365EM

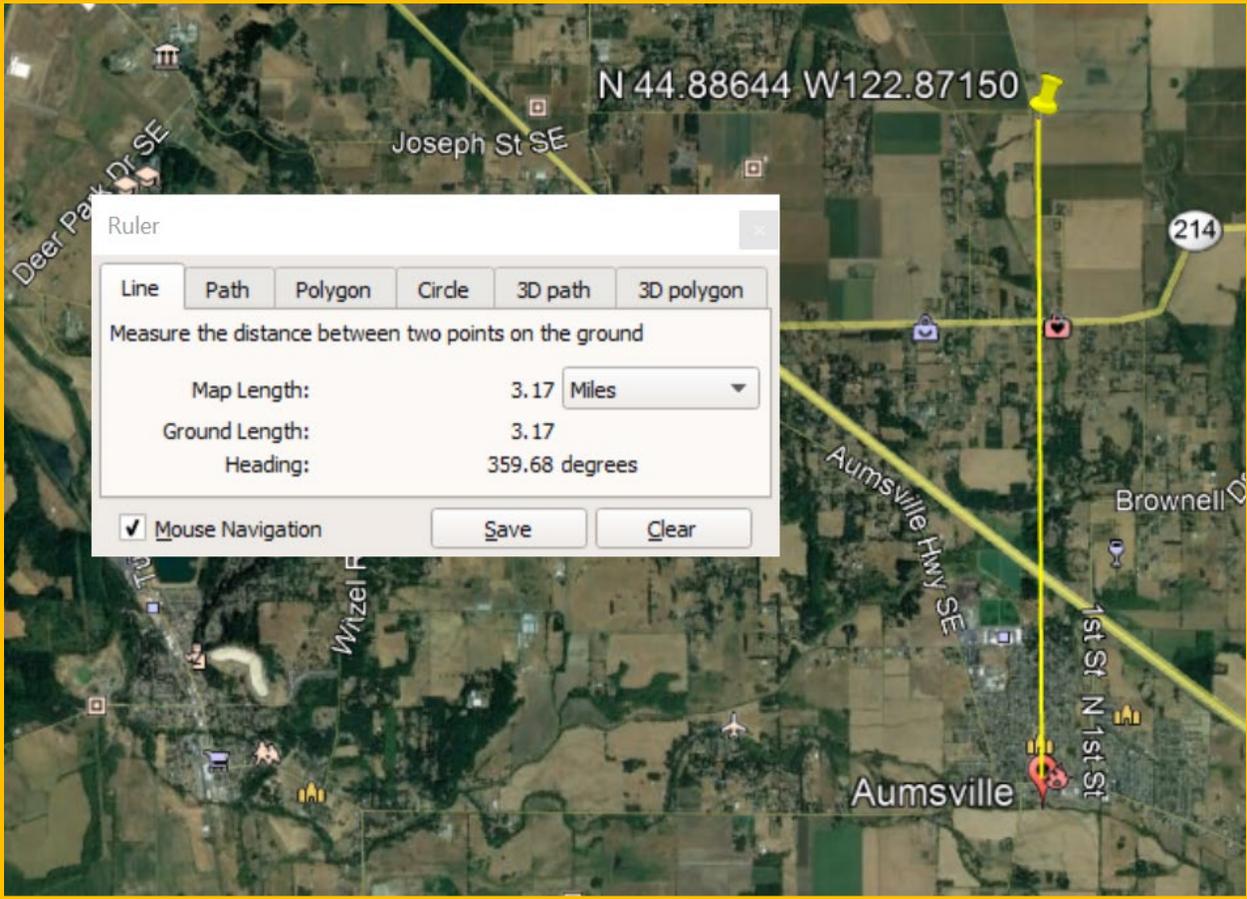
Figure 1: View of accident location relative to nearest city.

The accident site was a level alfalfa field located about 3 miles north of Aumsville, Oregon. The wreckage was oriented on a magnetic heading of 355°. The initial impact point (IIP) was located about 220 ft to the southeast of the main wreckage. The IIP was identified as a ground scar, approximately 4 x 8 inches deep and wide, and about 2 feet long.
